Appendix C Biological Resources

Title: Site Photographs – Belmont Crystal Springs School

Appendix 1
Photograph Exhibit
Crystal Springs Uplands School
Belmont, CA

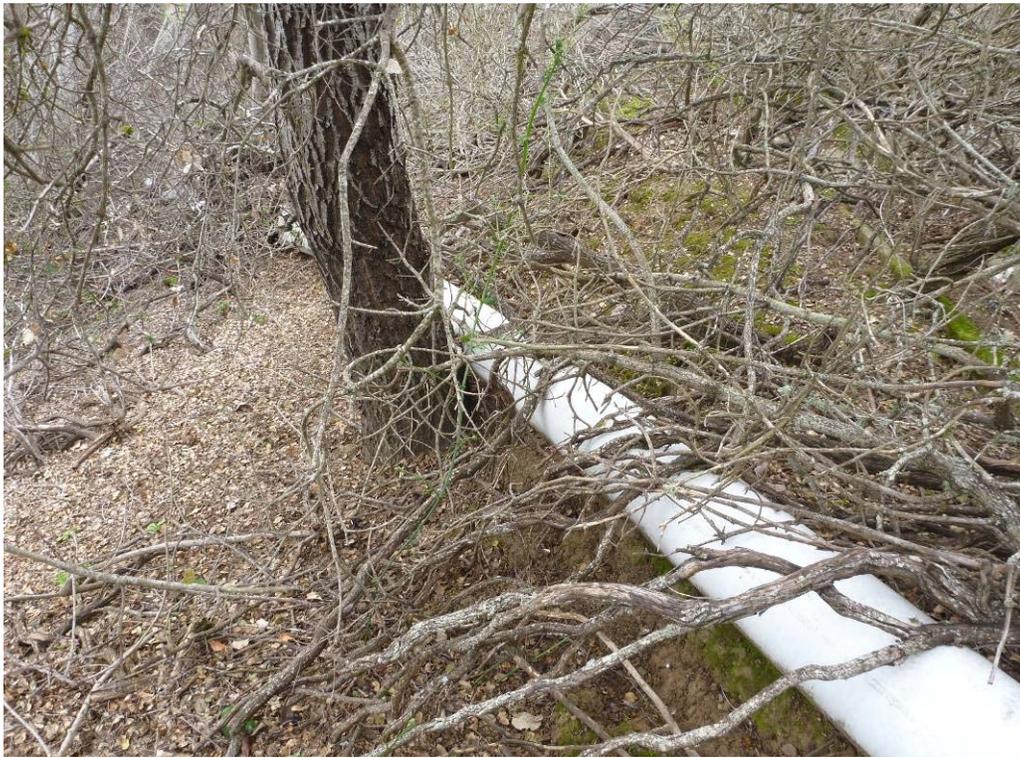
Photo 6: Manipulated intermittent creek in coast live oak woodland habitat in the southwest portion of the project site, facing south.

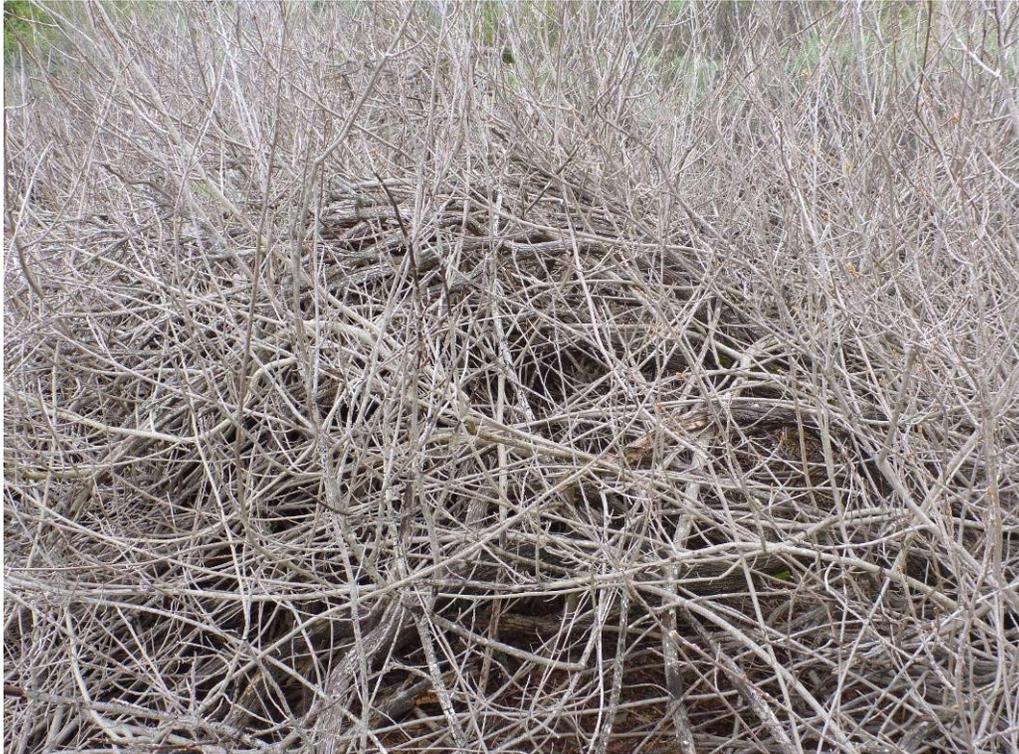
Photo 7: Potential San Francisco dusky-footed woodrat house in the coastal coyote brush scrub habitat in the southern portion of the project site.

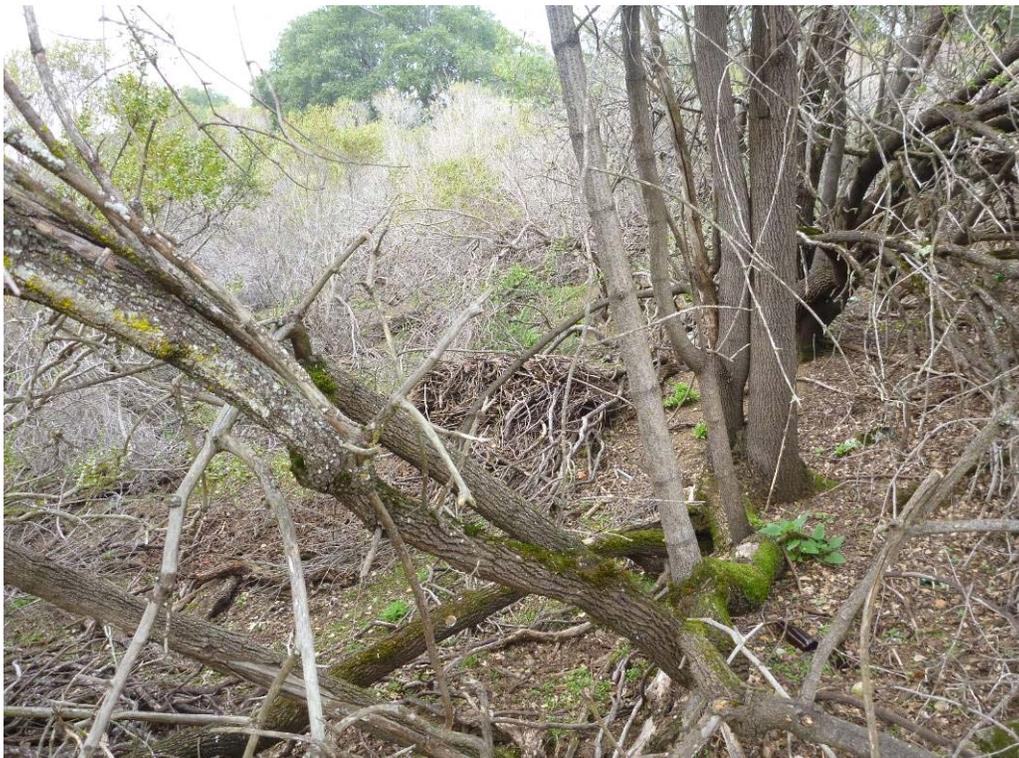
Photo 8: Potential San Francisco dusky-footed woodrat house in the coast live oak woodland habitat in the western portion of the project site.

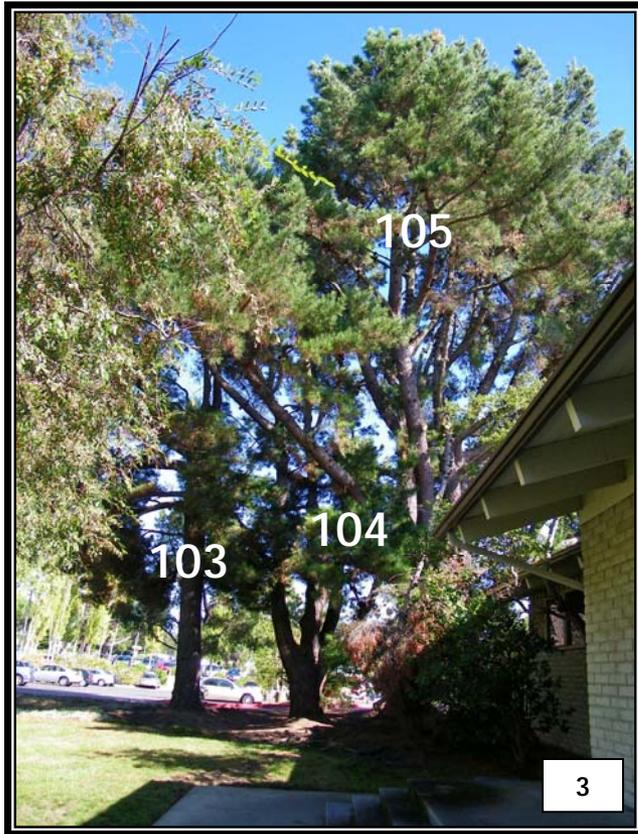
Photo 3. Monterey pine (103) and two Italian stone pines (104 & 105); a failed but attached branch on tree 105 could cause injury. This hazard is to be mitigated.

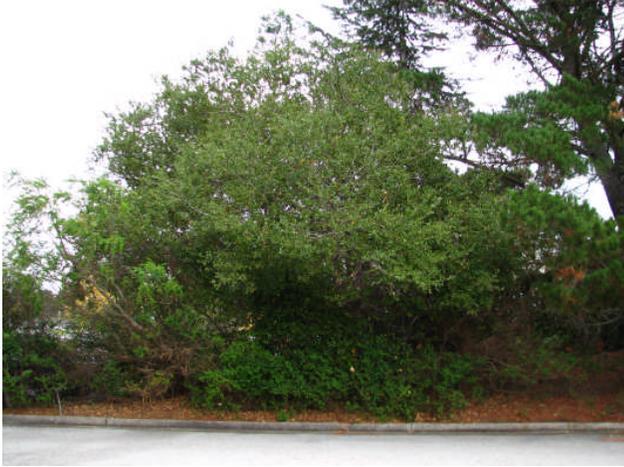
Coast live oak #178 overhanging into the existing parking lot where the proposed cafeteria will be located.

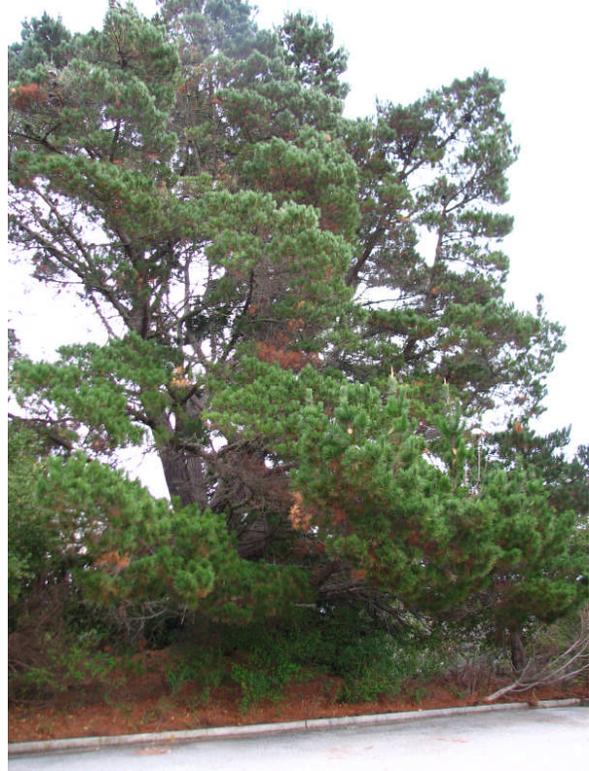
Monterey pine #179 also overhanging into the existing parking lot where the cafeteria will be situated.

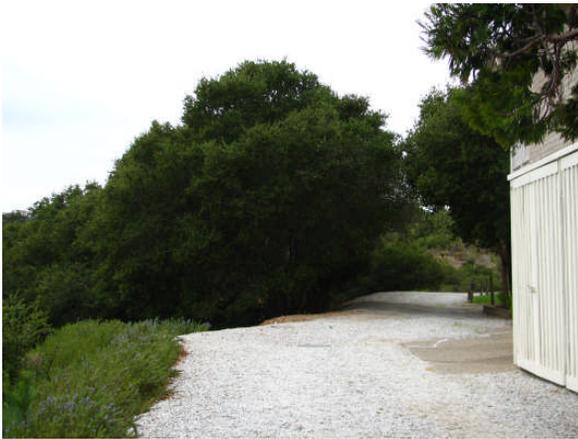
Looking west along the gravel driveway which acts as the south border of the property. The trees in the center of image comprise the native coast live oak forest consisting of trees #181 through #186, plus other coast live oak specimens downhill that were not included in my extension of the ROC survey.

Note that the oaks overhang the existing driveway where a low wall is proposed to be built. There is no way to install a wall here without significant oak canopy pruning and possibly oak root system severing for wall foundation footings, unless a pier and on-grade beam wall can be built using small equipment such as a 2-person breakdown drill rig.

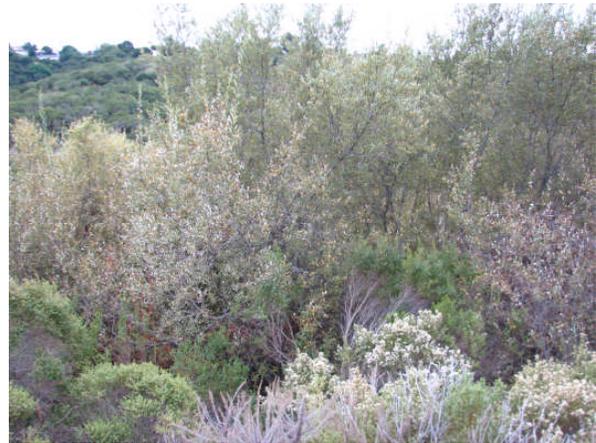
Native willow forest located just downhill from the proposed amphitheater and deck. This high value wildlife area is shown on the landscape plan as being demolished and replanted with other native species to create a green zone or "fire modification zone B" consisting of fire resistive plants and irrigation.

WLCA did not survey this area, as it is almost impenetrable with numerous protected size willows and poison oak, etc. It is suggested that the applicant have the project team clear brush and poison oak to allow their arborist ROC to tag, locate, and assess protected size trees in this border area.

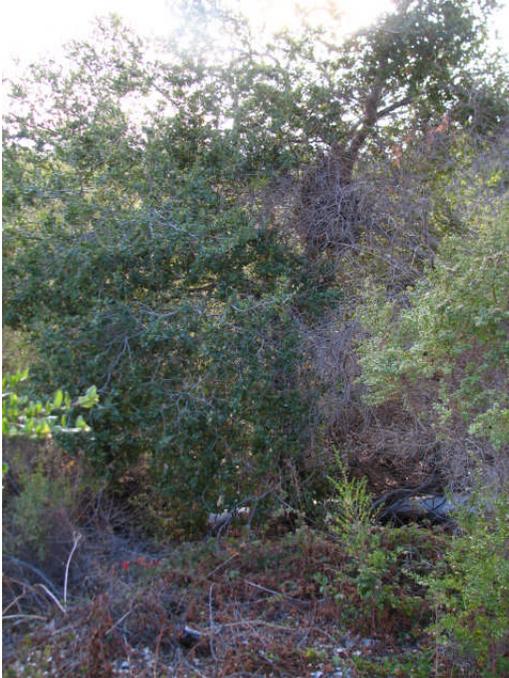
Center of image: Protected coast live oak #180 which may or may not be removed under the current proposed landscape plan.

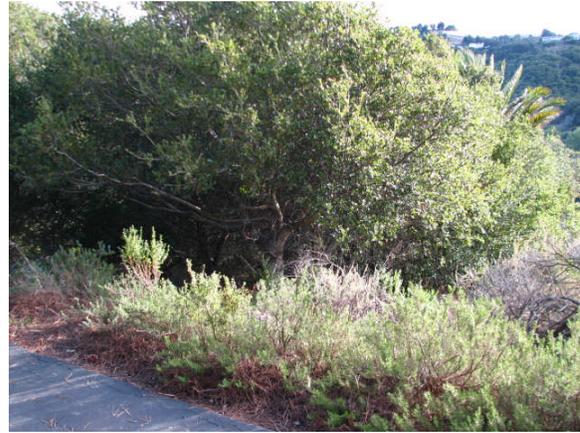
Looking east at protected coast live oak #181 which will be impacted by the proposed ADA ramp if built as proposed.

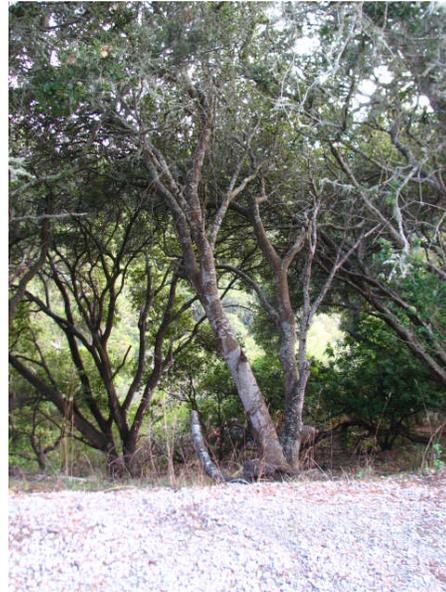
This tree has been negatively impacted by persons dumping fill and waste materials over the root zone, causing the root crown to become buried. I suggest reestablishing original grade around the tree by use of hand tools such as shovel and wheelbarrow which will increase oxygenation of the shallow root system and likely increase tree vigor over time.

Protected coast live oak #183 to be retained (same issues as noted for tree #182 at left).

As noted in condition #1, it is suggested that fill soil be removed by hand using hand shovels and wheelbarrows to reestablish original grade just north of oaks #182 through 186.

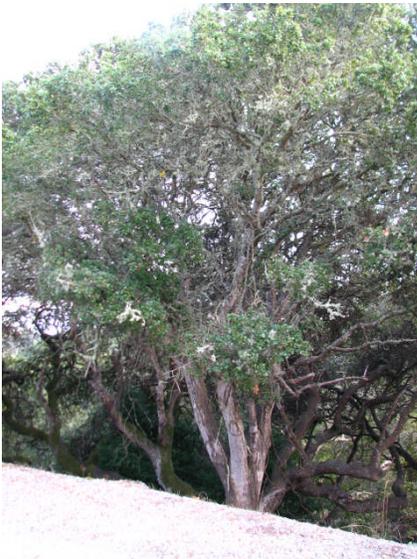
Protected size coast live oak #184 (same issues as tree #182 above).
