Appendix C Biological Resources

Title: Site Photographs – Belmont Crystal Springs School

Appendix 1
Photograph Exhibit
Crystal Springs Uplands School
Belmont, CA

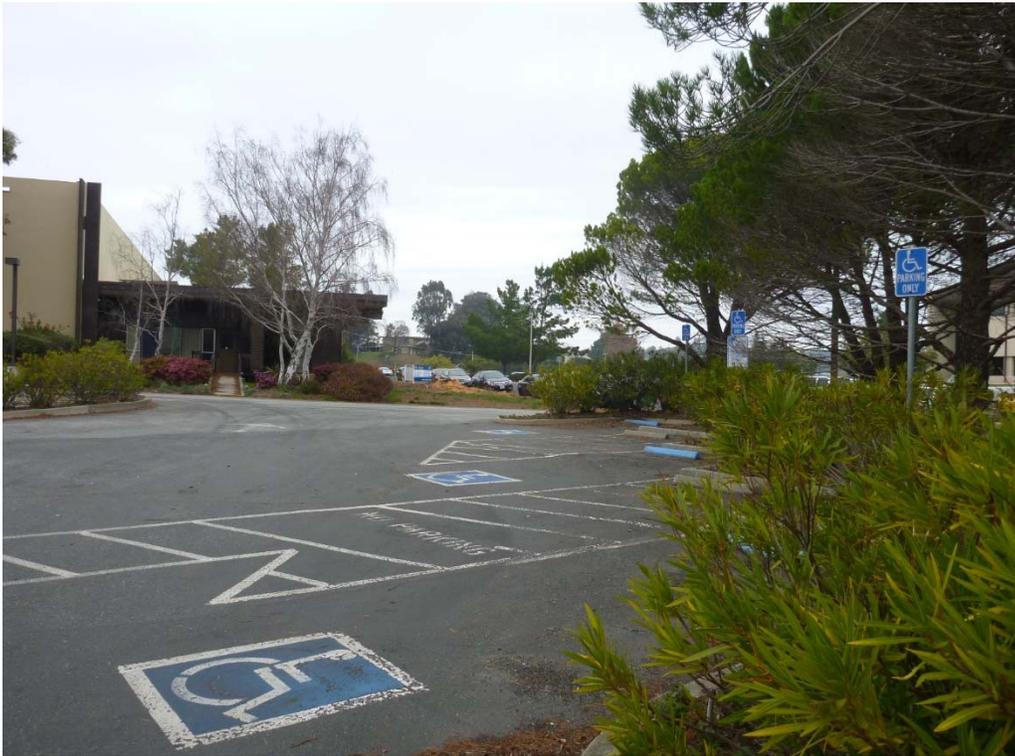
Photo 1: Representative photograph of developed habitat with intermittent ornamental vegetation, facing north.

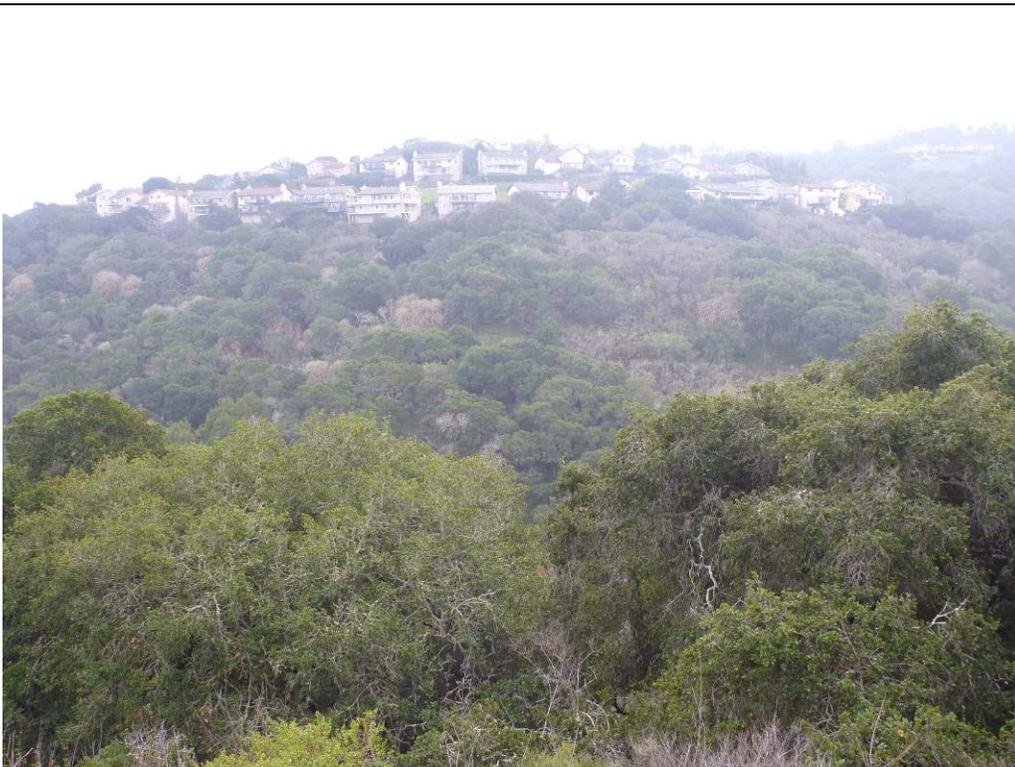
Photo 2: Representative photograph of coast live oak woodland habitat in the southern portion of the project site, facing south.

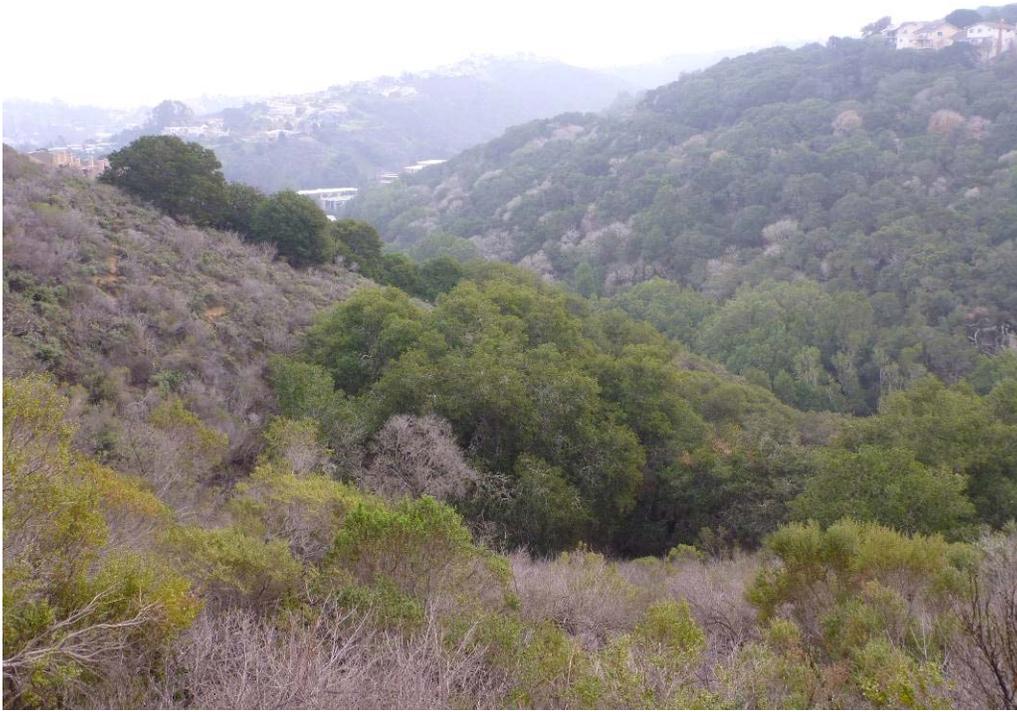
Photo 3: Representative photograph of coastal coyote brush habitat with coast live oak woodland in the background in the southern portion of the project site, facing southeast.

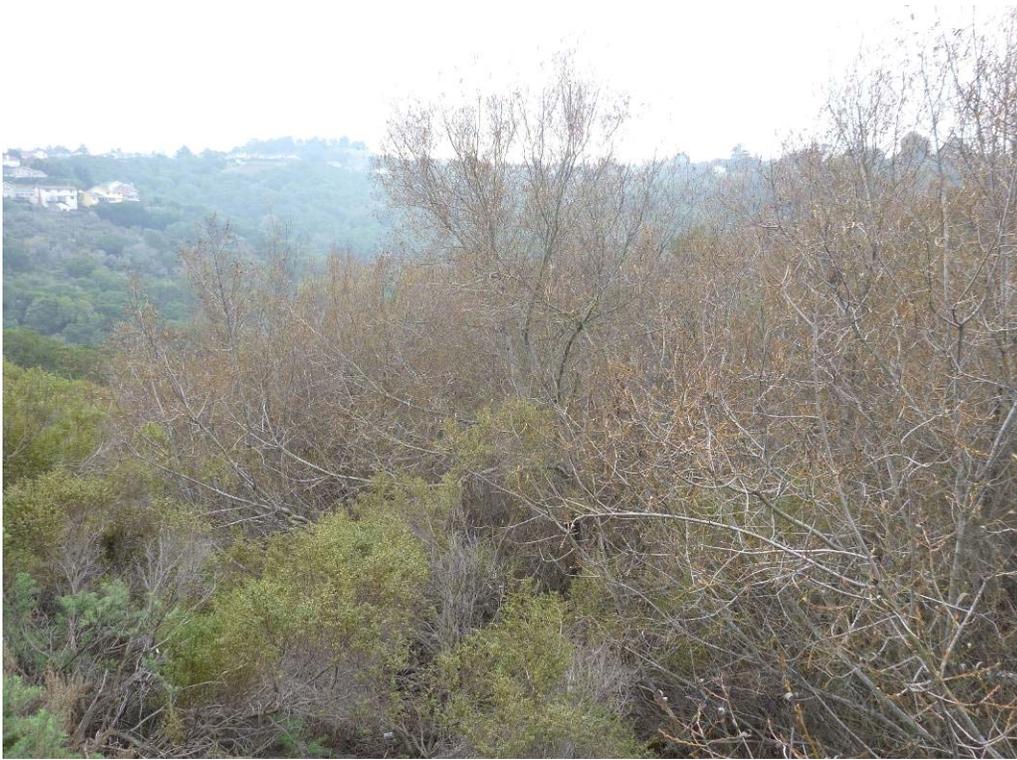
Photo 4: Willow thicket habitat in the southwest portion of the project site, facing southwest.

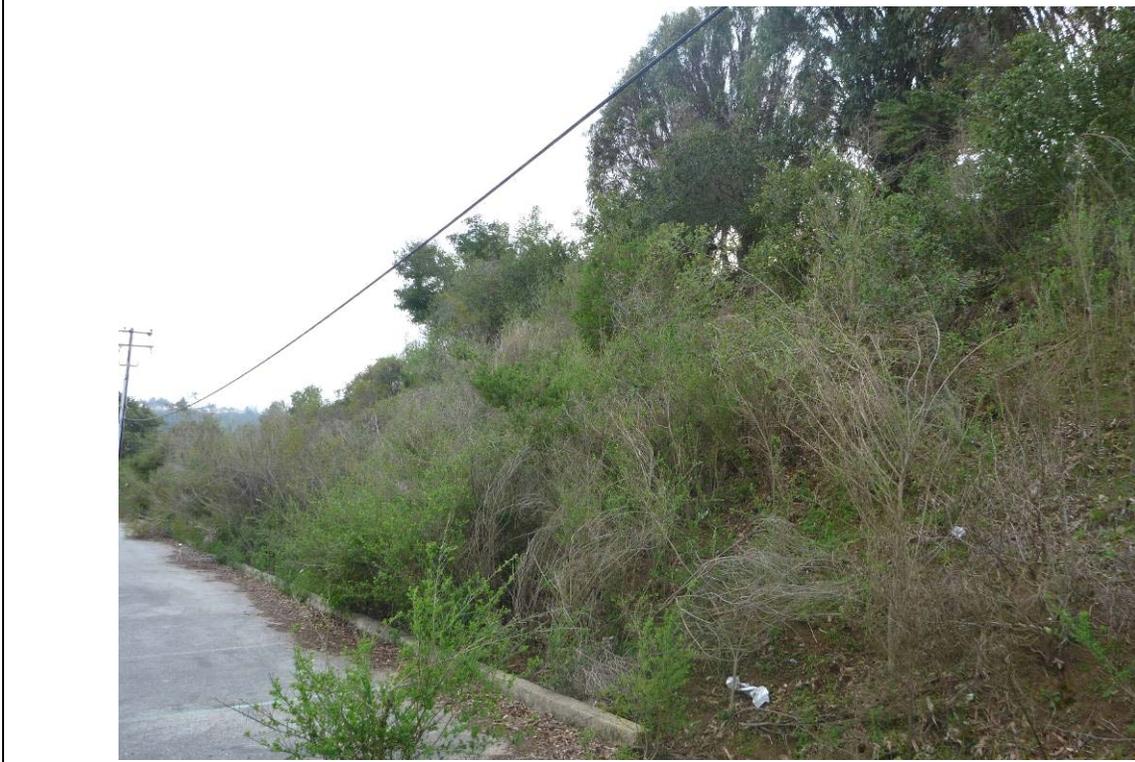
Photo 5: Representative photograph of disturbed coastal coyote brush habitat in the northwest project site, facing south.

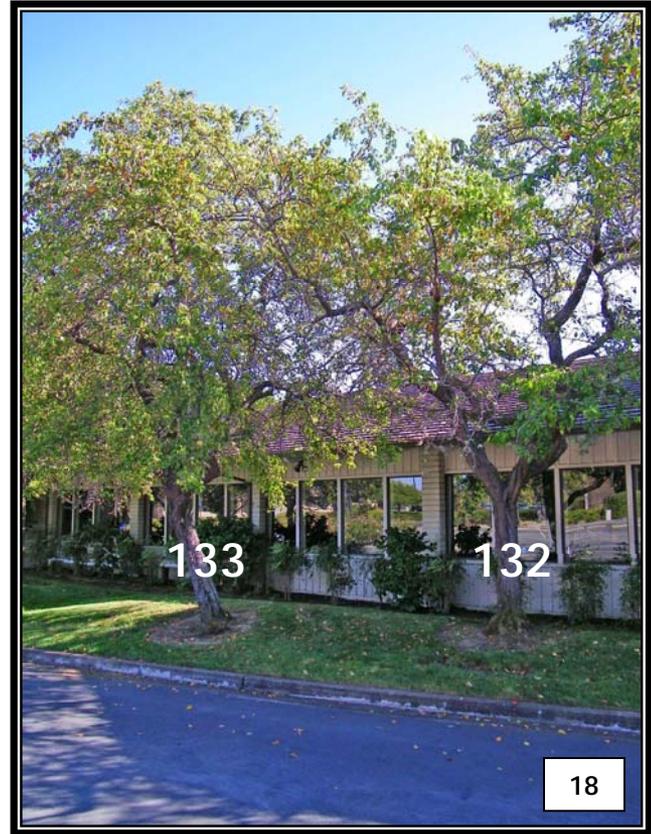
When properly maintained and pruned this species can be a focal point tree. These trees suffer from shade, overly wet soil conditions and inept pruning practices. Four (trees 132, 133, 134 and 135) of the six evergreen pears have been recommended for removal for reasons of poor structure and poor health.

Photo 18. two evergreen pears

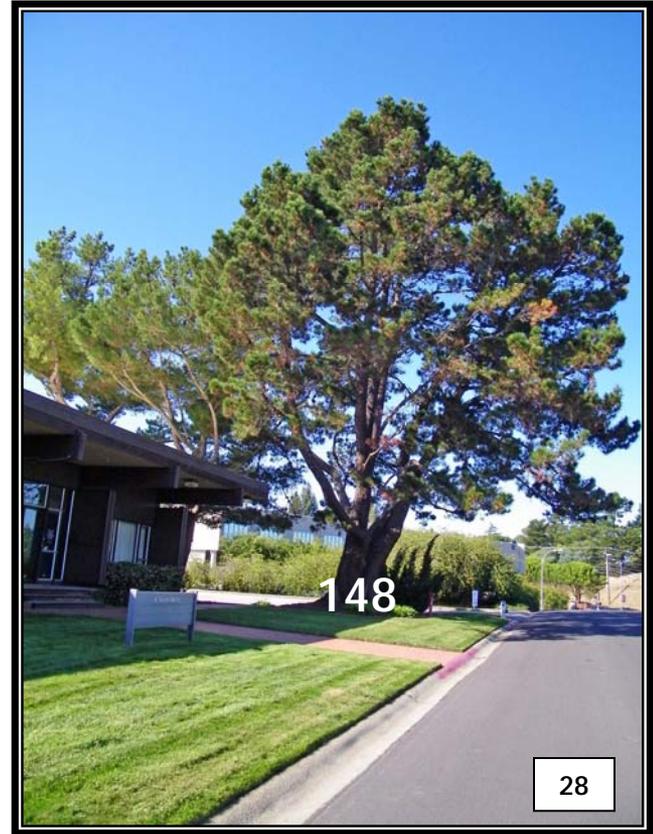
These over mature trees were observed to be in fair to very poor overall condition. Trees 148, 149 and 150 were recommended for removal for reasons of poor structure and poor health. When mature the Monterey pine is not tolerant of soil disturbances. The tree species is not suitable for the urban landscape.

Photo 28. Monterey pine

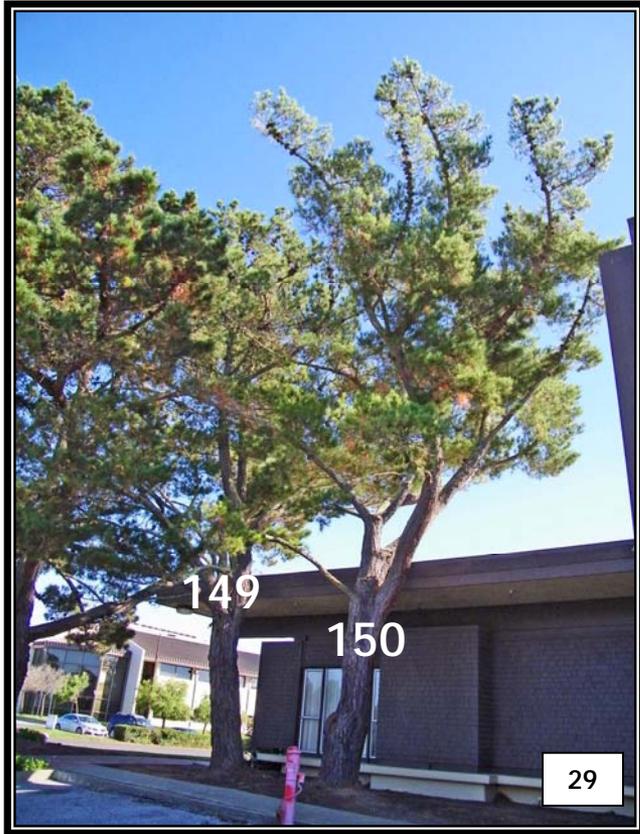
Photo 29. two Monterey pines

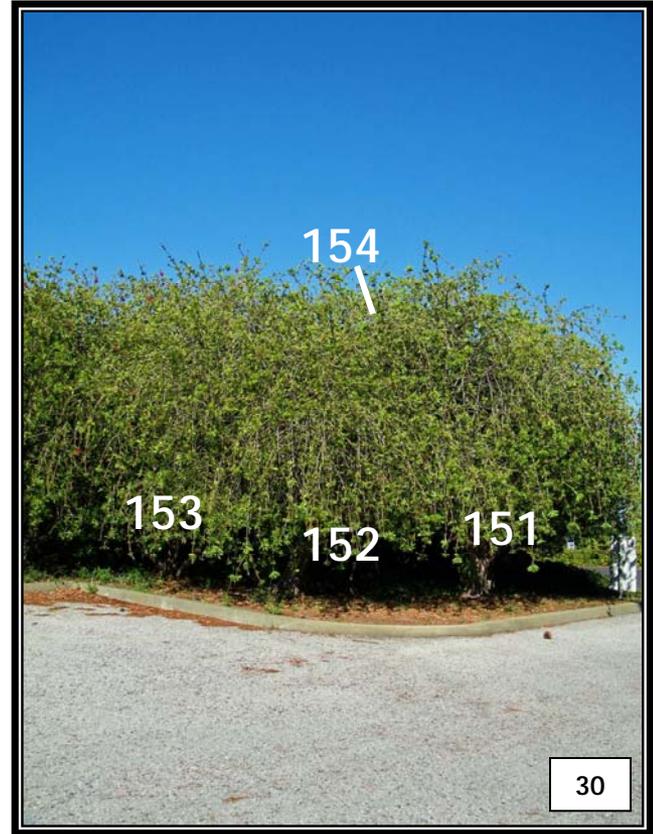
Here is a tree that became a shrub. It is a drought tolerant native of Australia. Four were growing together forming a shared canopy and were observed to be in overall good condition. Tree 136 was recommended for removal for reasons of poor structure and poor health.

Photo 30. four weeping bottlebrushes
begin a hedge between properties

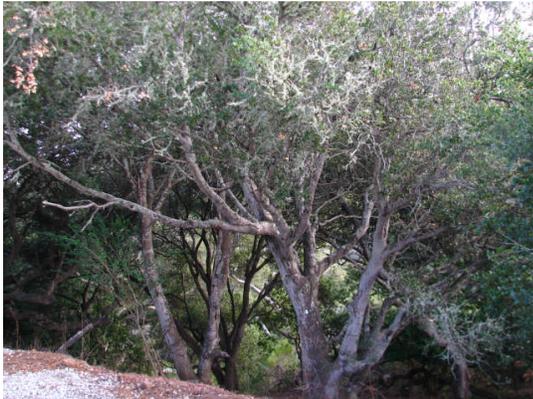
Protected coast live oak #182 to be retained.

This tree has been negatively impacted by persons dumping fill and waste materials over the root zone, causing the root crown to become buried. I suggest reestablishing original grade around the tree by use of hand tools such as shovel and wheelbarrow which will increase oxygenation of the shallow root system and likely increase tree vigor over time.

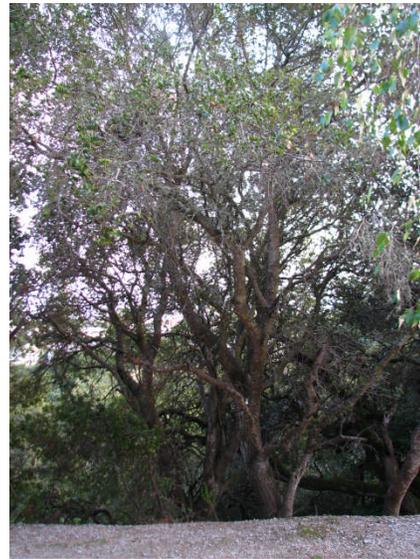
Protected size coast live oak #185 (same issues as tree #182 above left).

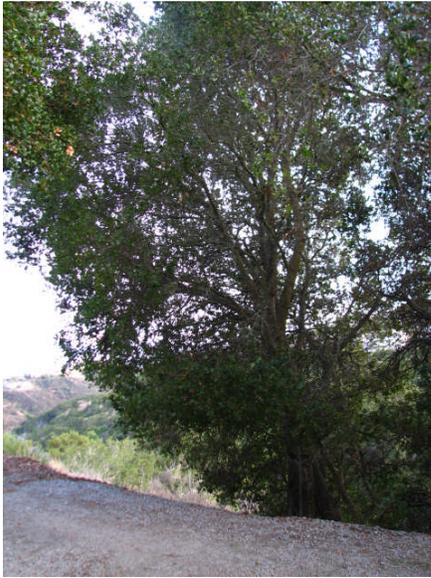
Protected size coast live oak #186
(same issues as tree #182 above left).
